HISTORY  
OF  
CORPS OF ENGINEERS  
ACTIVITIES  
AT  
SCHILLING AIR FORCE BASE

MARCH 1960 --- DECEMBER 1961

UNITED STATES ARMY  
CORPS OF ENGINEERS BALLISTIC MISSILE CONSTRUCTION OFFICE  
LOS ANGELES 43, CALIFORNIA

WS-107 A-1, ATLAS F MISSILE SILO  
SCHILLING AIR FORCE BASE  
SALINA, KANSAS

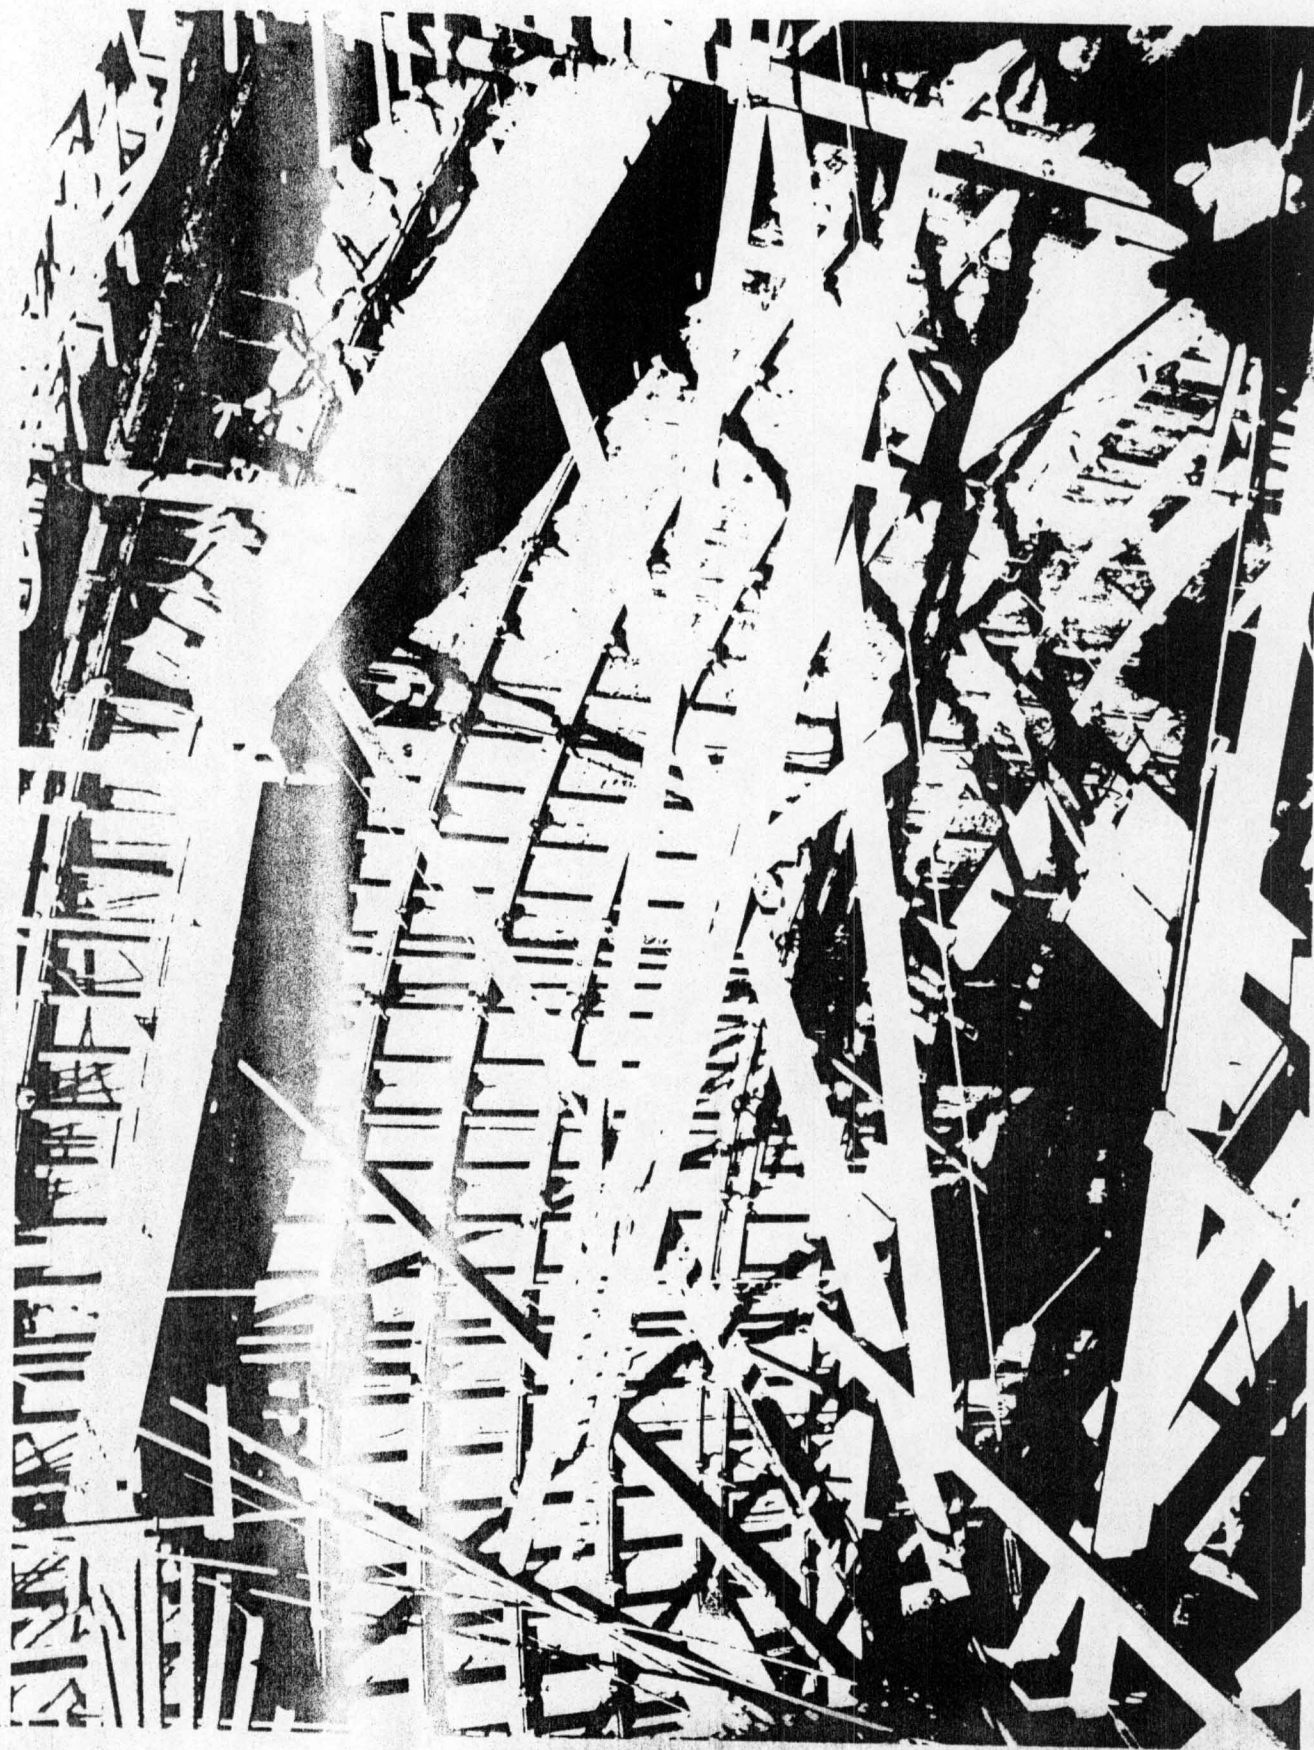
Figure 25. Inside floor work for LCC.

Forms for the LCC, vestibule and stairway were made of 3/4" plywood. Supports for the plywood varied from 2" x 4" to 8" x 8" clear, straight grained timbers; sizes depended on whether the material was to be used for supports for ceiling forms, bracing, or framing for forms. Metal scaffolds (with screw feet, allowing forms to be lowered from position upon removal) were used to support the roof slab of the LCC. The walls of the LCC were formed by double form wall. Construction she-bolts were used to hold the forms in their set position during placing of concrete. Three sets of exterior forms and four sets of interior forms were used to build the walls of the twelve LCCs. Figure 25 shows form work inside the LCC and figures 26 & 27 show form work outside the LCC.

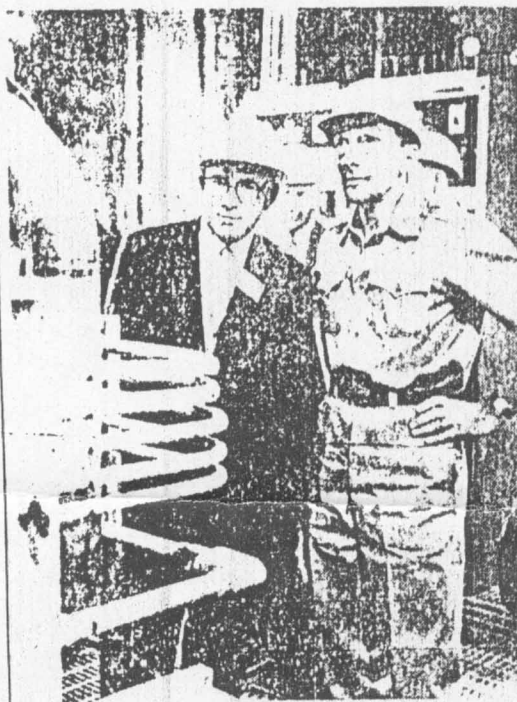
INSPECTING PART OF THE INTRICATE SYSTEM of valves and pipes that has been installed to transport liquid oxygen and hydrogen are E. W. Littlefield, executive vice-president and general manager of Utah Construction & Mining Co., and Maj. Gen. Alvin Charles Welling, deputy for site activation for the Corps of Engineers. The liquid gasses will be used for rocket fuel.
